## International Journal of Disaster Risk Reduction

# Rebuilding historic urban neighborhoods after disasters: Balancing disaster risk reduction and heritage conservation after the 2015 earthquakes in Nepal

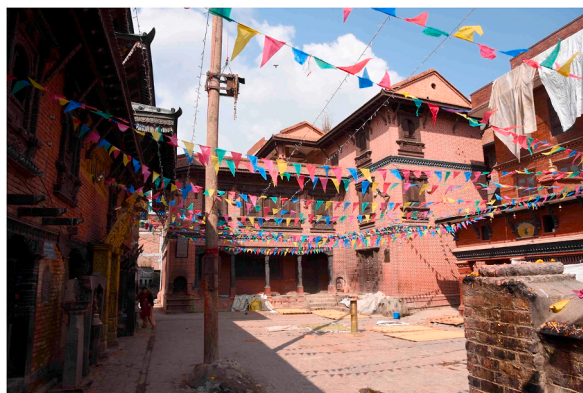
Fig. 1. Example of core area of traditional Newari town in the Kathmandu Valley (Photo P. Daly).

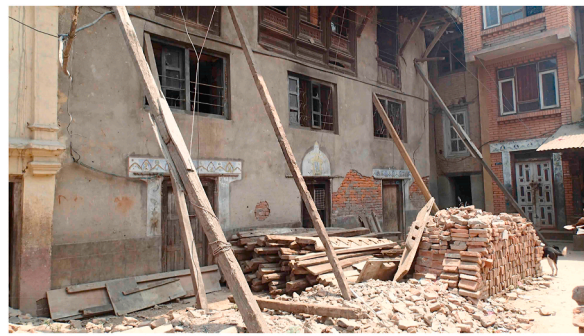
Fig. 3. Example of historic building in Patan damaged by the earthquakes and supported by wooden braces. (Photo P. Daly).

Some of the houses collapsed during the earthquakes, but many were partially damaged and remained standing and largely intact. During the initial damage assessment, government engineers and architects identified still-standing structures that were unsafe for habitation due to structural damage. Some owners dismantled these buildings, leaving vacant lots while waiting for reconstruction. Some of the damaged structures were left standing, abandoned and propped up with make-shift wooden braces and in some cases still used/occupied in spite of regulations (Fig. 3).

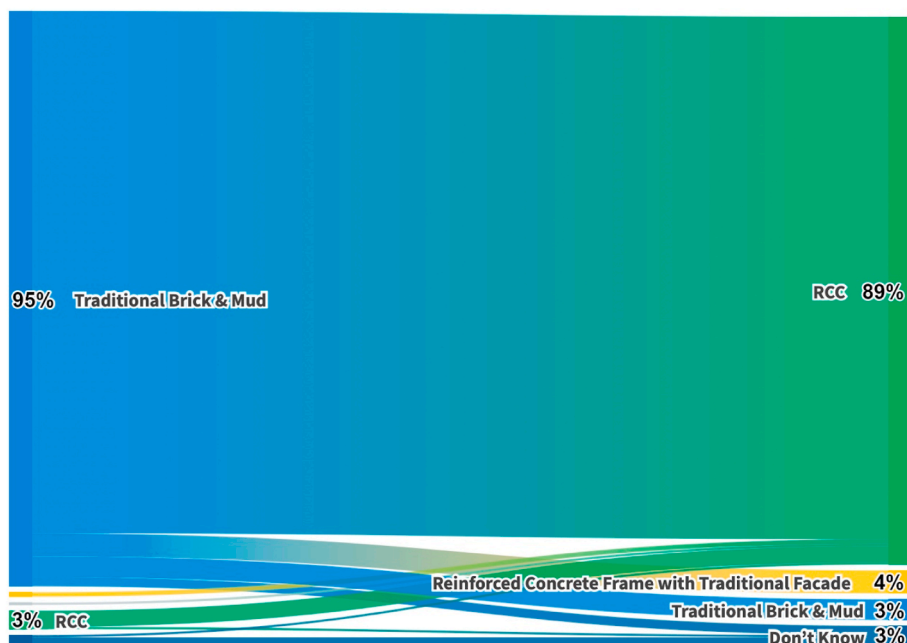
Fig. 7. Alluvial chart of changes of housing type for Harisiddhi. The left side of the plot shows the pre-earthquake housing composition. The right side of the plot shows how each damaged house was transformed during the reconstruction.
